# EXPLOSION ACCIDENT EVALUATION OF MV. GILI CAT II USING APOLLO ROOT CAUSE ANALYSIS METHODOLOGY

Ricard Diago Sambuaga  
NRP 4213 101 046

DEPARTMENT OF MARINE ENGINEERING  
Faculty of Marine Technology  
Institut Teknologi Sepuluh Nopember  
Surabaya  
2017

*The highest percentage of accident investigation (2007-March 2017) of National Transportation Safety Committee (NTSC) is caused by fire or explosion (38%). MV. Gili Cat II had been exploded September 15<sup>th</sup>, 2016 at Padangbai port, Bali. MV. Gili Cat II is a passenger ship that serves from Padangbai Port, Bali to Gili Ketapang, Lombok. There were 35 passengers on board when ship was exploded. From this accident, there were 2 passengers got fatalities. Related to the explosion of MV. Gili Cat II, Root Cause Analysis and giving recommendation is needed (especially for electrical system and fuel oil system). Apollo Root Cause Analysis that used in this thesis. This is recommended for event / incident-based items of complex and higher significance. Recommendation of this thesis is referring the NCVS (Non-Conventional Vessel Standard) Ch. V and NFPA refueling procedures. As the result of the analysis, the explosion is cau

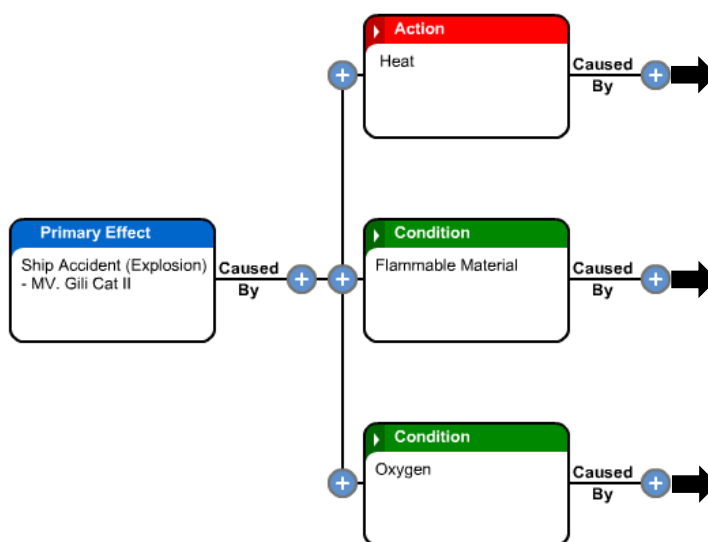
Figure 4. 4 Chart (Explosion MV. Gili Cat) part 1 <sup>6</sup>

1.0 Why the Ship Accidents (Explosion) - MV. Gili Cat II can happen?

- 1.1 Why Heat can happen?
  - 1.1.1 (A) Static electrical around of the tank and hull
  - 1.1.2 (C) Bad electrical wiring system

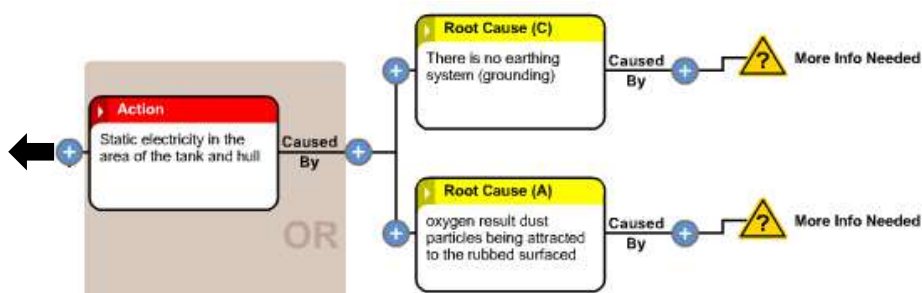
Figure 4. 6 Chart (Explosion MV. Gili Cat) part 3 <sup>8</sup>

- 1.1.1 Why are there a static electricity in the area of the tank and hull?
  - 1.1.1.1 (C) There is no earthing system (grounding) – STOP (More Info Needed)
  - 1.1.1.2 (A) oxygen result dust particles being attracted to the rubbed surfaced – STOP (More Info Needed)

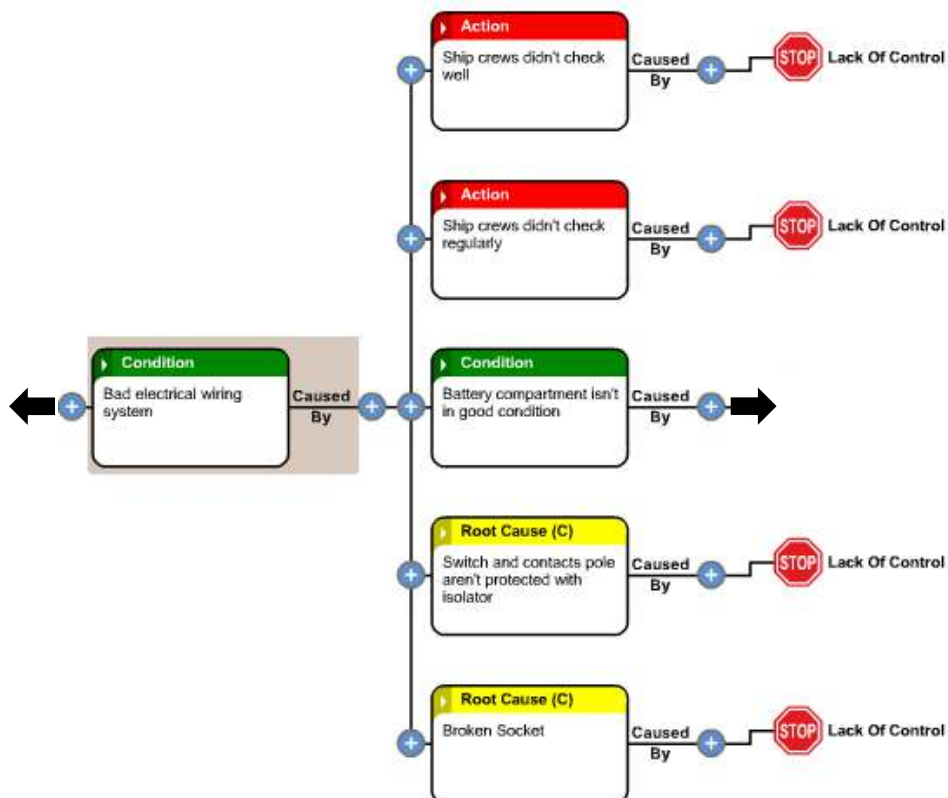
Figure 4. 11 Chart (Explosion MV. Gili Cat) part 4 <sup>13</sup>

- 1.1.1.1 Why battery compartment is not in good condition?
  - 1.1.1.1.1 (A) Ship crews tightening battery using belt tied manually – STOP (Desired Condition)
  - 1.1.1.1.2 (C) There is a gap between battery spaces and refueling pipeline space – STOP (Lack of Control)
  - 1.1.1.1.3 (C) Battery spaces is not in good condition – STOP (Lack of Control)
  - 1.1.1.1.4 (C) Wood boards and sponges as a prop for battery – STOP (Desired Condition)

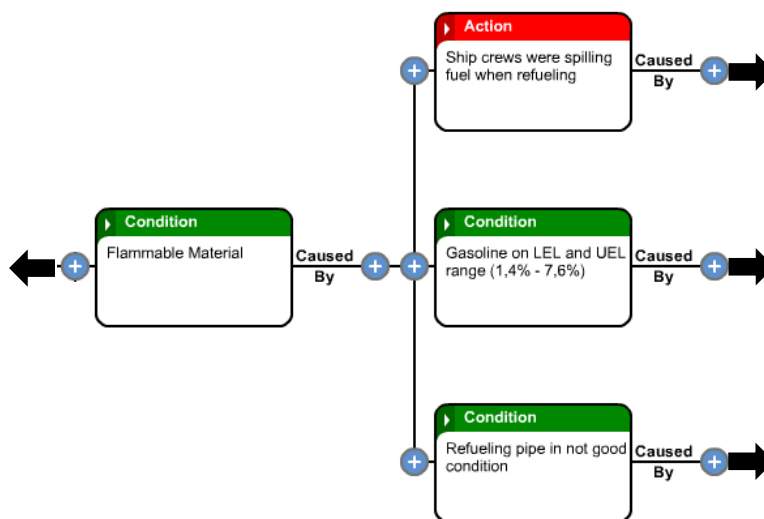
Figure 4.13 Chart (Explosion MV. Gili Cat) part 6 <sup>15</sup>

- 1.1 Why are there flammable materials?
  - 1.1.1 (A) Ship crews were spilling fuel when refueling
  - 1.1.2 (C) Gasoline on the LEL and UEL Range (1,4% - 7,6%)
  - 1.1.3 (C) Refueling pipe is not in good condition

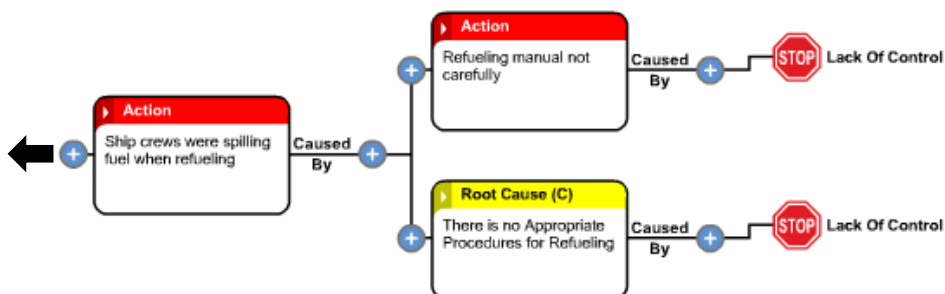
Figure 4.14 Chart (Explosion MV. Gili Cat) part 7 <sup>16</sup>

1.2.1 Why ship crews were spilling fuel when refueling?

1.2.1.2 (C) There is no appropriate procedures for refueling  
- STOP (Desired Condition)

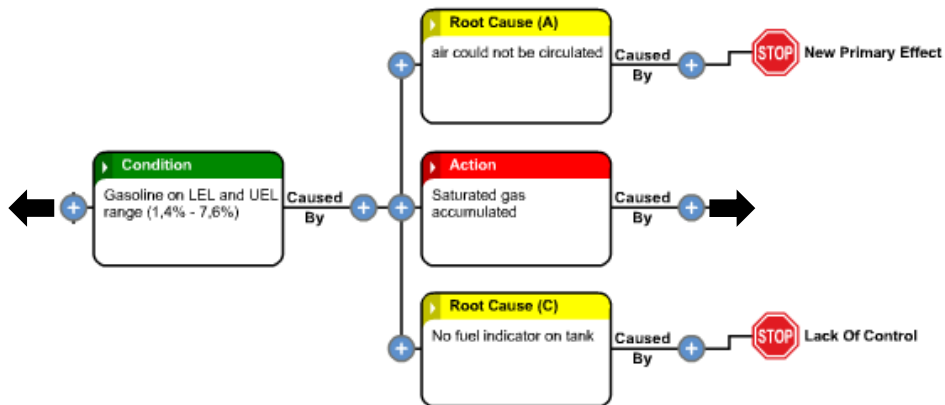
Figure 4. 15 Chart (Explosion MV. Gili Cat) part 8 <sup>17</sup>

1.2.2 Why there are gasoline on the LEL and UEL range (1,4% - 7,6%)?

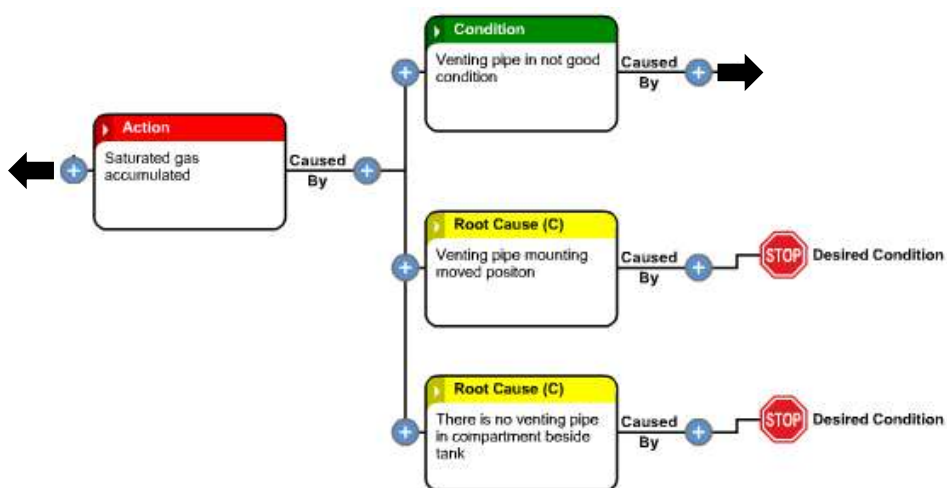
Figure 4. 17 Chart (Explosion MV. Gili Cat) part 9 <sup>19</sup>

- 1.2.2.2 Why are there saturated gas accumulated?
- 1.2.2.2.1 (C) Venting pipe is not in good condition
- 1.2.2.2.2 (C) Venting pipe mounting moved position – STOP (Desired Condition)
- 1.2.2.2.3 (C) There is no venting pipe in compartment beside fuel tank – STOP (Desired Condition)

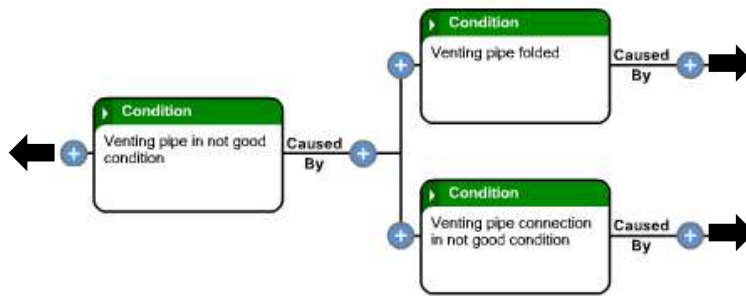
Figure 4. 18 Chart (Explosion MV. Gili Cat) part 10<sup>20</sup>

1.2.2.2.1 Why the venting pipe is not in good condition?

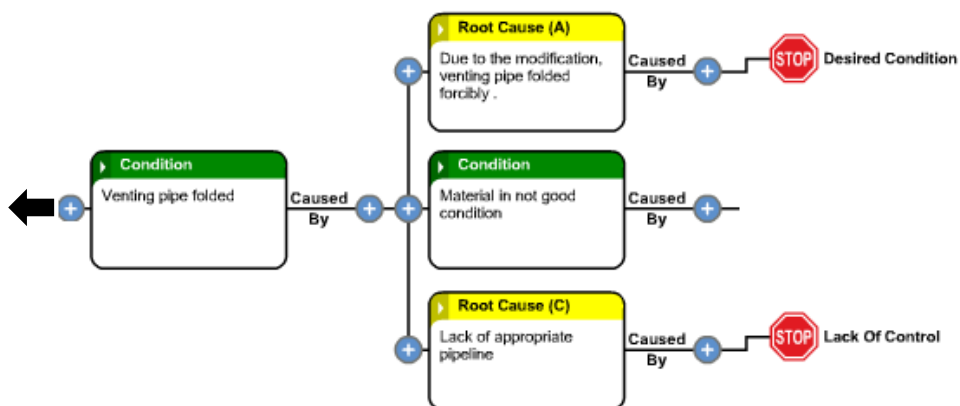
Figure 4. 20 Chart (Explosion MV. Gili Cat) part 11 <sup>22</sup>

1.2.2.2.1.1 Why venting pipe was folded?

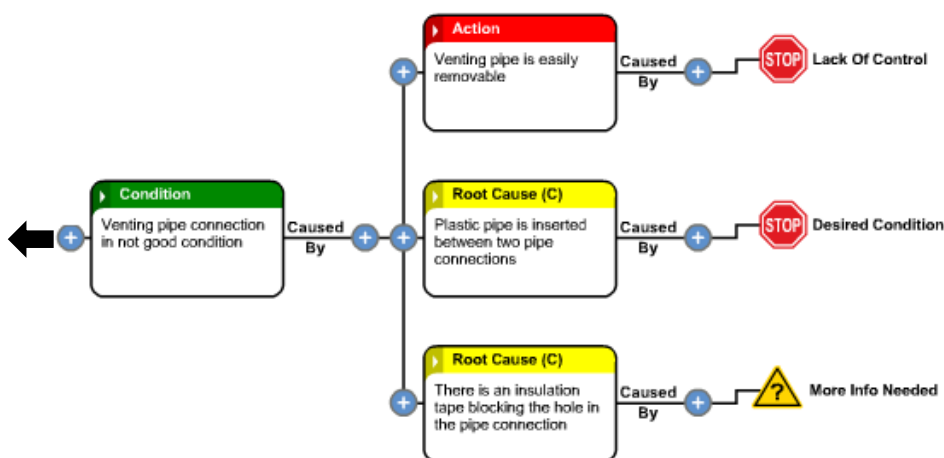
Figure 4.24 Chart (Explosion MV. Gili Cat) part 12<sup>26</sup>

1.2.2.2.1.2 Why the pipe venting pipe connection is not in good condition?

1.2.2.2.1.2.1 (C) Plastic pipe is inserted between two pipe connection - STOP (Desired Condition)

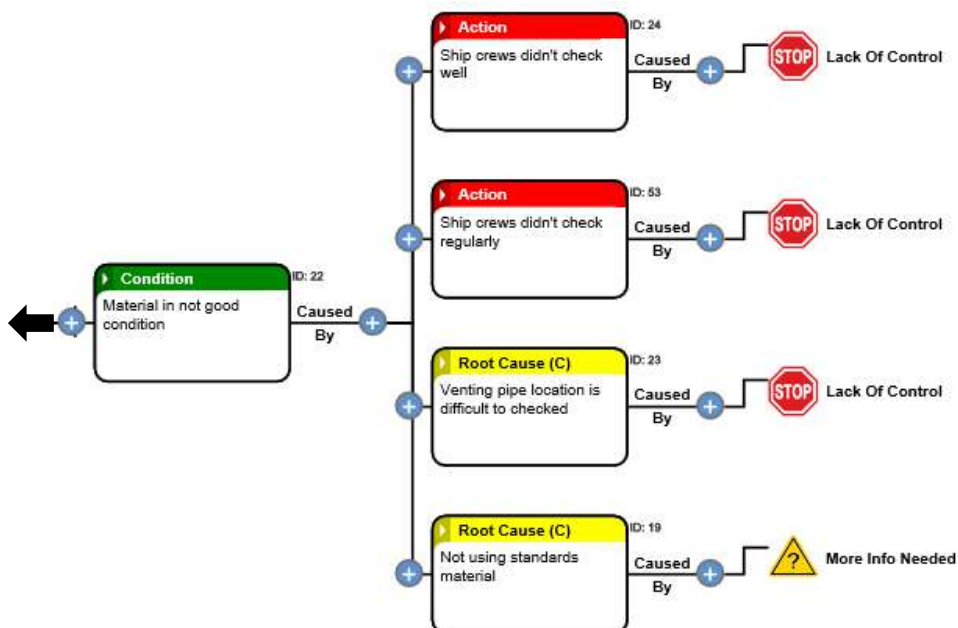
Figure 4. 26 Chart (Explosion MV. Gili Cat) part 13 <sup>28</sup>

In the eleventh stage is continued on Figure 4. 26 given the question why are there 1.2.2.2.1.1.2 (C) Material is not in good condition in the ninth stages. The answer of this question is as follows:

- 1.2.2.2.1.1.1 Why the material is not in good condition?
- 1.2.2.2.1.1.1.1 (A) Ship crews did not check well - STOP (Lack of Control)
- 1.2.2.2.1.1.1.2 (A) Ship crews did not check regularly - STOP (Lack of Control)
- 1.2.2.2.1.1.1.3 (C) Venting pipe location is difficult, to checked - STOP (Lack of Control)
- 1.2.2.2.1.1.1.4 (C) Not using material standards - STOP (More Info Needed)

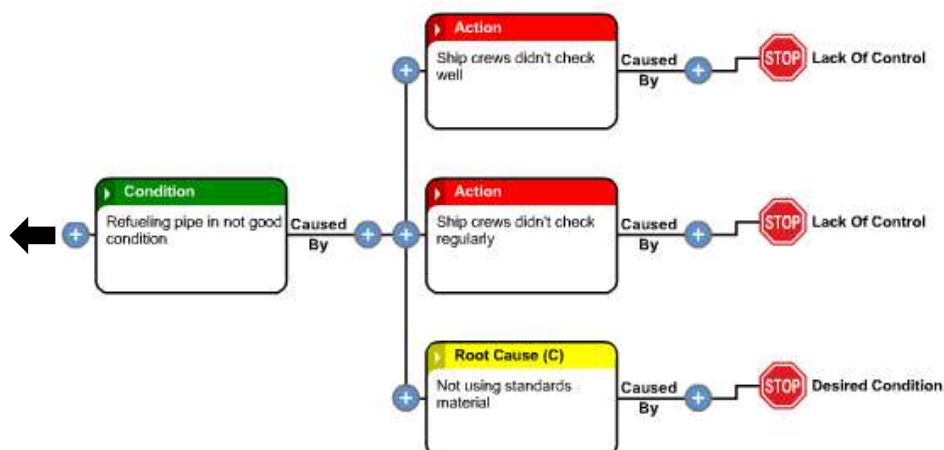
Figure 4. 28 Chart (Explosion MV. Gili Cat) part 14 <sup>30</sup>

### 2.2.3 Why the refueling pipe is not in good condition?

- 1.2.3.1 (A) Ship crews did not check well - STOP (Lack of Control)
- 1.2.3.2 (A) Ship crews did not check regularly - STOP (Lack of Control)
- 1.2.3.3 (C) Not using material standards - STOP (Desired Condition)

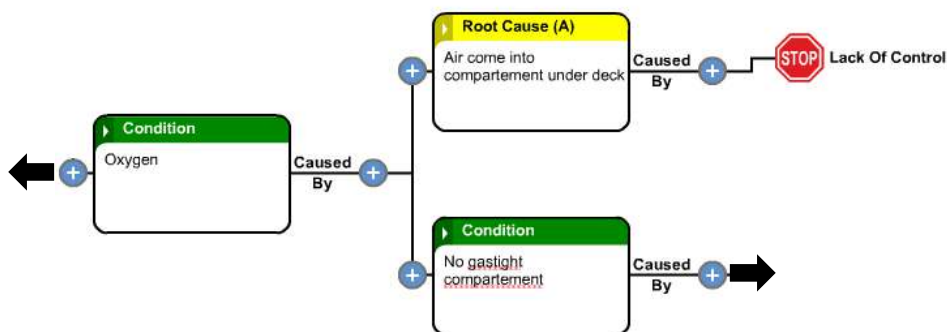
Figure 4. 29 Chart (Explosion MV. Gili Cat) part 15 <sup>31</sup>

### 1.3 Why there is Oxygen?

1.3.2 (C) No gastight compartement

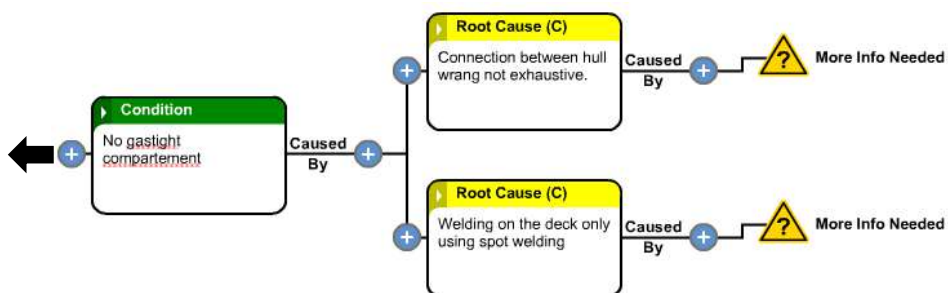
Figure 4. 30 Chart (Explosion MV. Gili Cat) part 16 <sup>32</sup>

### 1.3.2 Why the compartement is not watertight?
